SERVICING MANUAL FOR SPINALIS® CHAIRS

Outline of Servicing Procedures

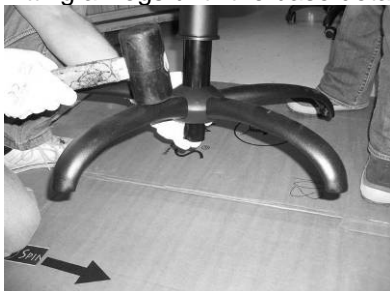
A) The person A holds the SpinaliS® chair and raises it approximately 20cm above the floor (please make sure to adequately protect the floor). The person B uses a rubber hammer and hits the metal base repeatedly as close as possible to the centre of the gas pump. The person B should continue hitting all legs until the base detaches from the gas pump.

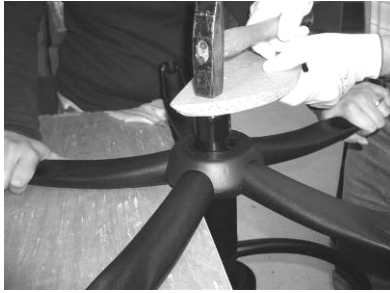
B) Alternatively, you can turn the SpinaliS® chair upside down and position the base on a solid foundation (please make sure to place protective material on the table surface to prevent the metal base from scratching). Position and hold a piece of wood at the bottom of the gas pump and hit it with

a heavy metal hammer until the gas pump detaches from the base. Please make sure to hold the SpinaliS® chair firmly throughout the procedure so that it does not fall on the ground.

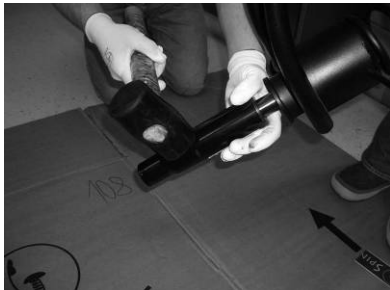
The person A holds the SpinaliS® chair and raises it some 20 cm above the floor (which should be adequately protected). The person B keeps hitting the gas pump from different sides with a rubber hammer until the gas pump is separated from the spring mechanism.

Sometimes it may happen that the gas pump cannot be removed due to a conoid joint between the lift and the spring mechanism. In such case the spring mechanism needs to be replaced as well. After executing the procedure explained above you can install all components which need replacing and reassemble the SpinaliS® chair. Please do not forget the decorative gas pump cover.

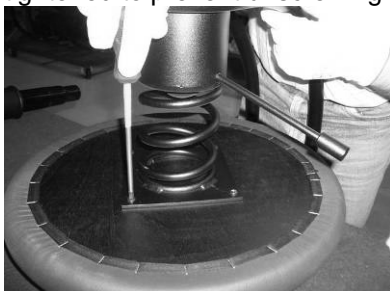
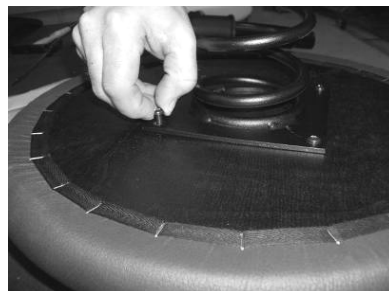
If a seat needs to be replaced, please position the SpinaliS® chair so that the seat is placed flat on a table. Please unscrew the four screws, which hold the seat in place and replace the padded seat. Screw back the screws by **manually inserting each screw into the individual hole. Please screw it tightly for a couple of times to make sure that the screw fits well into the coil.** You can use a screwdriver only after the described steps are completed. This way a possible detaching of wooden nuts from the seat, which would damage the seat is prevented. The screws have to be securely tightened to prevent unscrewing.

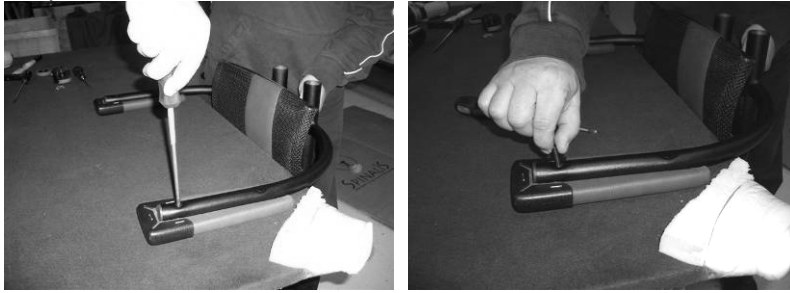
Before replacing the armrest remove the backrest from the spring mechanism. Alternatively lift the entire SpinaliS® chair and place it upside down on a table. Make sure to hold the chair the entire time so that it does not fall on the ground. First remove the circular protective sticker from the screws and unscrew the two screws. Next, replace the padded part of the armrest. Screw back the screws by manually inserting each screw into the individual hole. Please screw it tightly for a couple of times to

make sure that the screw fits well into the coil. You can use a screwdriver only after the described steps are completed. The screws have to be securely tightened to prevent unscrewing. Then repeat the procedure for the other armrest, if needed.

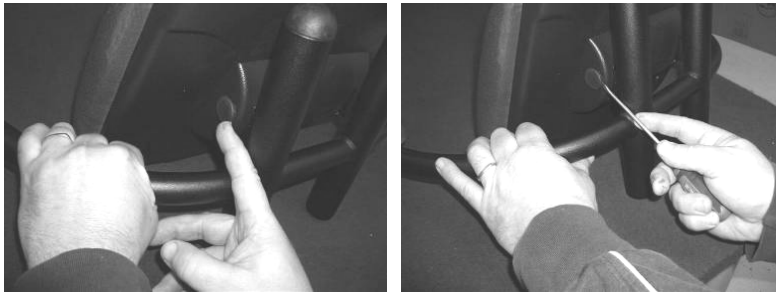
First, please remove the PVC plug on the left and the right side of the ABS cover with a hand nail or a regular screwdriver (the exceptions are models HK and SP).

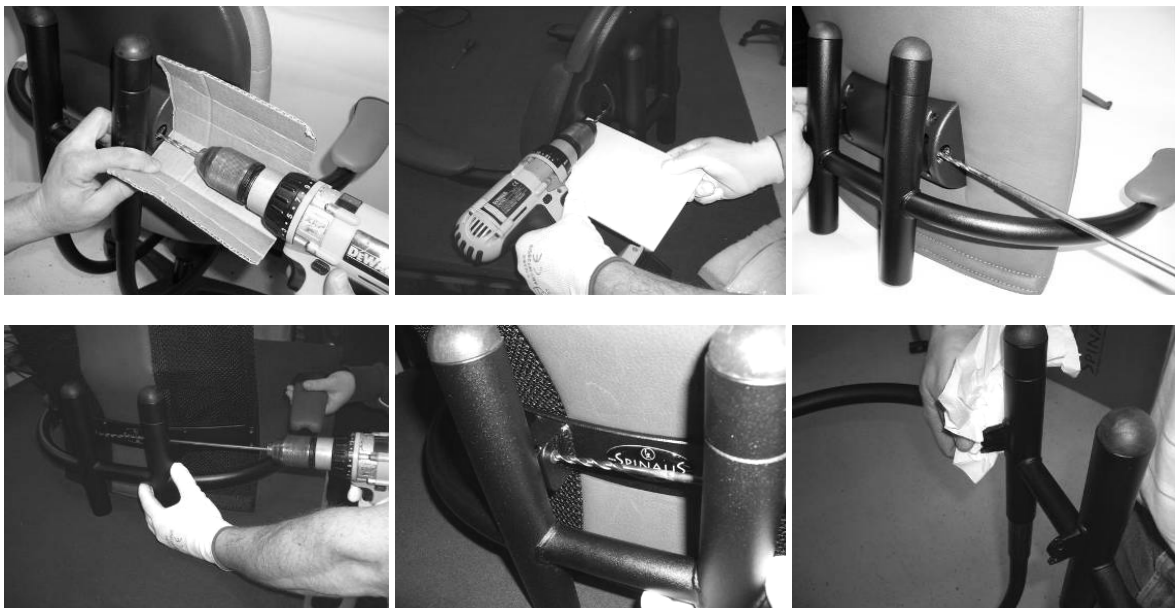
Use an electric d5 mm drill to bore through the rivet holding the backrest. Use an extended 5mm drill for models HK and SP in order to be able to reach the rivet situated in the inside of the frame. Please make sure not to damage the frame or the backrest whilst executing this activity. The person B should insert a PVC or a cardboard protection between the frame, the drill and the backrest. At the same time the person B should also make sure to hold the backrest firmly so that it does not fall to the floor once the person A finishes drilling through both rivets. You can also use an extended 5mm, 20 cm long drill in order to decrease possibilities of damaging the SpinaliS® chair.

After drilling through both rivets please separate the backrest from the metal backrest frame. Please also remove any parts of the rivet, which may have remained in the metal frame by either drilling it through or by using a screwdriver and a hammer. Hit the remaining rivet parts and so remove them from the hole. Please clear away all metal parts immediately thereafter to prevent making the padded parts dirty.

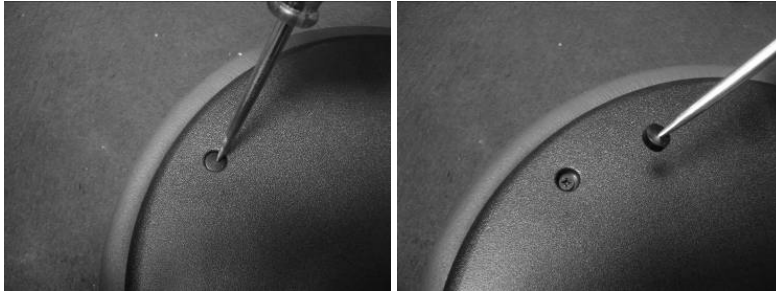
If you wish to disassemble the backrest (BS, AP, NG), please place it on a working surface, remove protective stickers or plugs from screws and unscrew them to remove the PVC cover. Wipe the metal frame with a rag and make sure to remove any chips that were caught in grease whilst drilling.

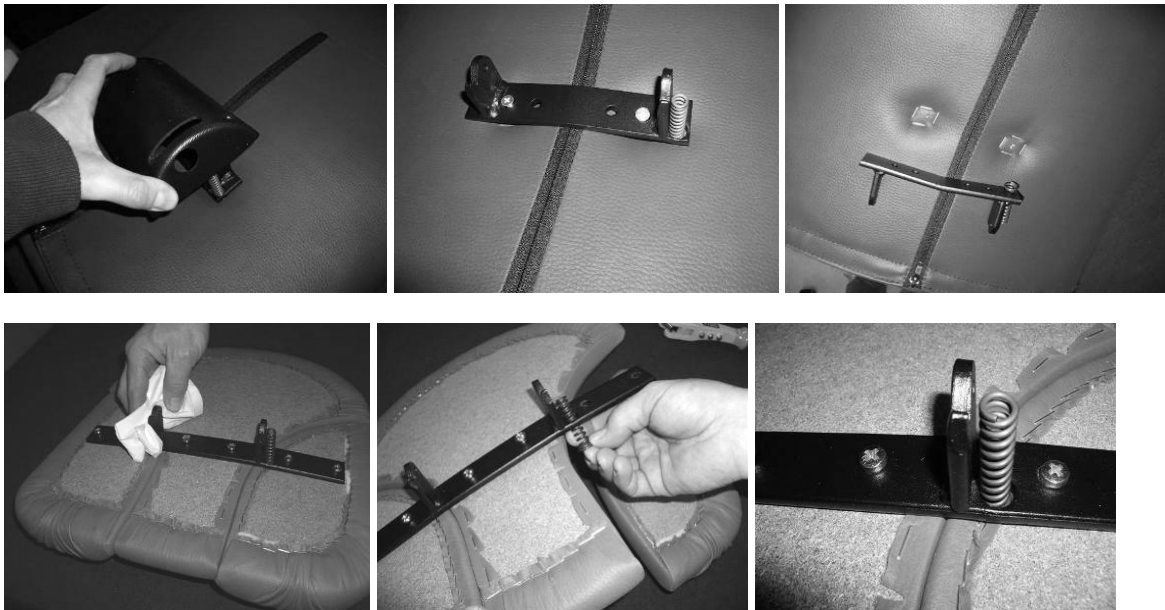
If you have to replace the small spring in the backrest holder, please unscrew the screws, which hold the backrest and the metal wood holder. Replace the spring with a new one and please make sure to position it so that it is not in contact with the metal frame. Finally screw back the wood holder and PVC cover.

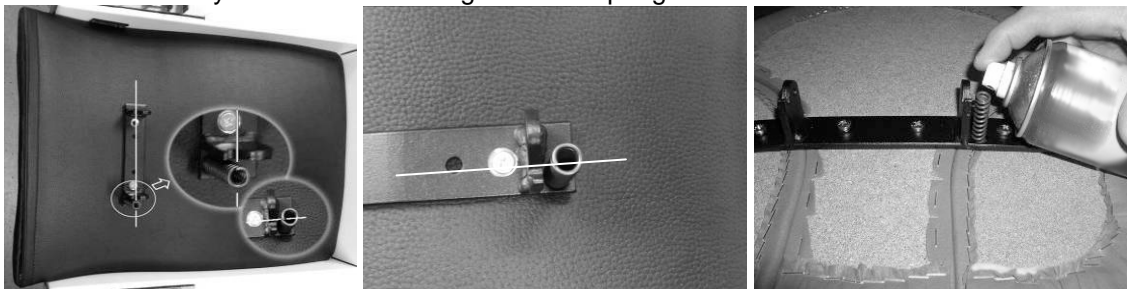
Before reassembly make sure to oil or grease the spring.

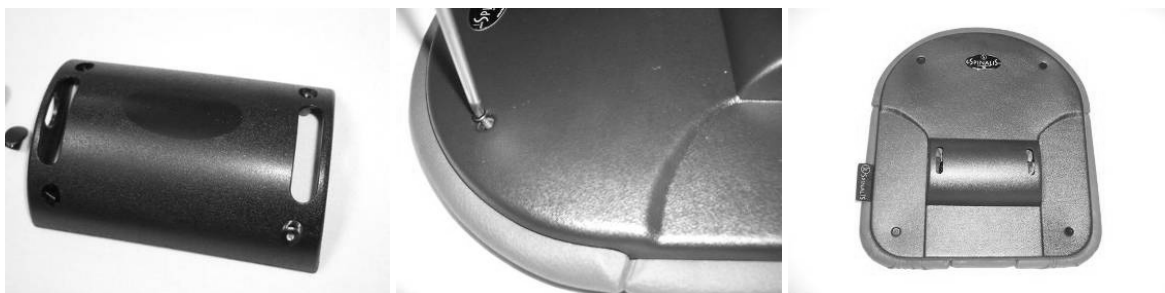
Please place the ABS/PVC cover onto the backrest (do make sure to place it in centre of the frame) and screw it evenly with 4 screws. If you are dealing with an AP and NG model, please place the ABS/PVC cover so that the cut in the cover is positioned closer to the upper side of the backrest.

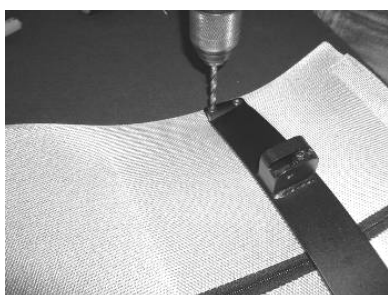
Should you want to separate the backrest from the backrest holder (model HK or SP) please use the 5mm drill to drill through 4 rivets holding the backrest and the backrest holder. After drilling through the rivets please first make sure to remove any chips occurred due to drilling and clean the backrest and the holder with a rag.

In the event that the small spring in the backrest holder is broken, the holder will need to be replaced with a new one.

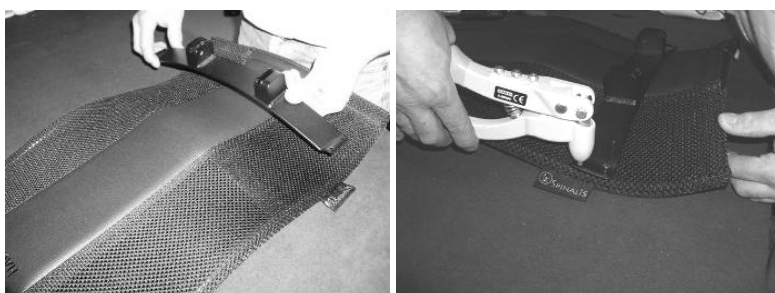
Fix the backrest holder to the backrest with four rivets. Place the backrest onto a working surface. Place the backrest holder so that all four holes on the backrest and on the holder are aligned. Insert the rivets and fix them using specific tongs.

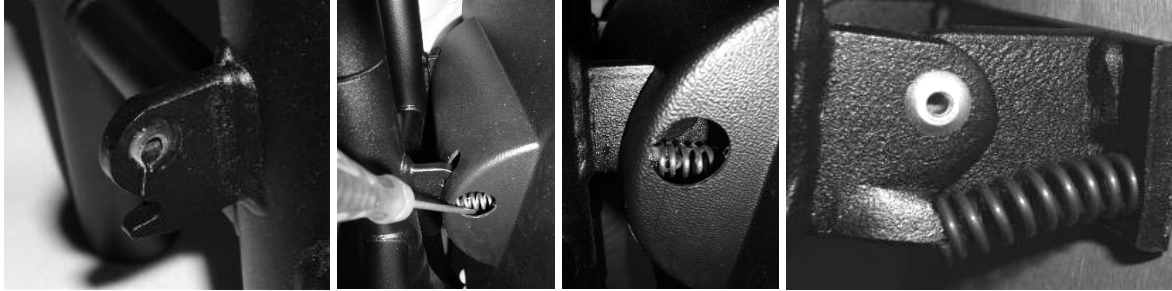
Before reassembly please apply grease to the surface of both holders on the metal frame (grease should be applied to holder surfaces, which slide against each other).

Please place the backrest next to the holders on the metal frame. First insert the left rivet as there is no spring on this side, which makes re-positioning easier. The right side holds the backrest spring, which needs to be positioned onto a smaller pin in the holder with the help of a screwdriver.

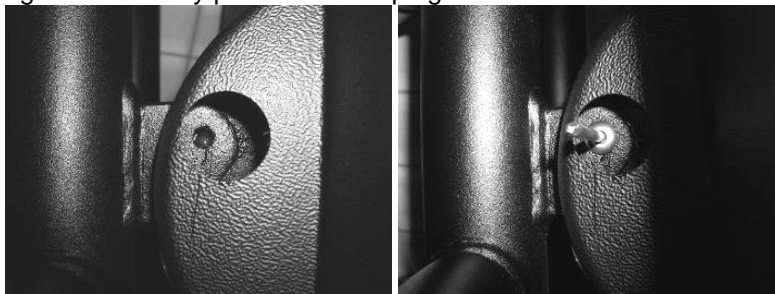
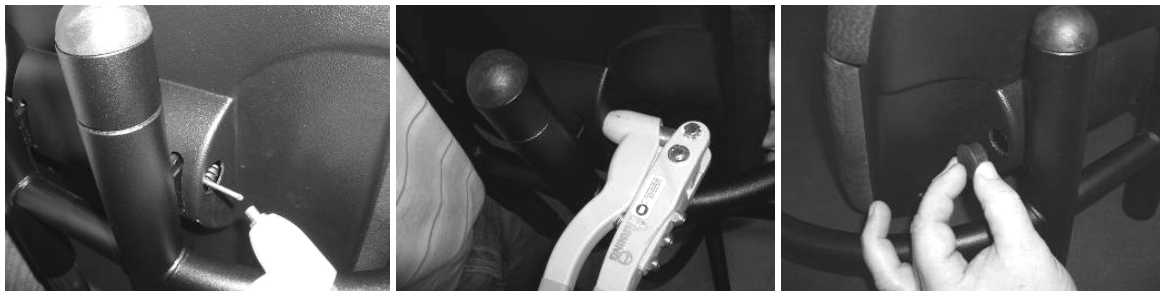
Once the small spring is placed onto the pin please gently move the backrest to the position in which both holes are aligned. Insert the rivet. Use manual tongs and please first fix the left rivet and then the right rivet. Finally place the PVC plug onto the PVC cover.

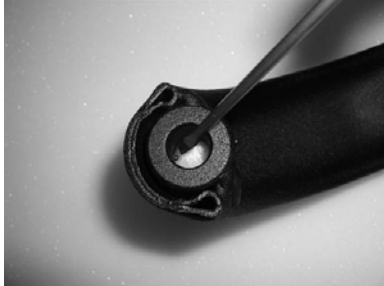
Should you be unable to insert the caster into the base due to small metal chips, left over from welding, please remove the chips by gently hitting them with the tip of the screwdriver or with the caster shaft. Insert the caster using harder pressure.

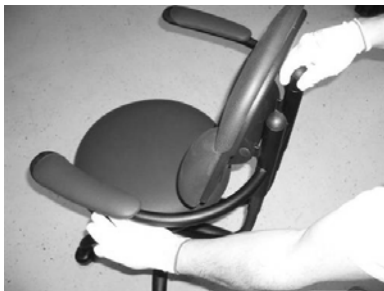
Deficiencies arising when assembling the backrest and the spring mechanism – cases when the backrest mechanism is stuck or inactive (the button used to raise the backrest cannot be rotated anymore).

A) In most cases this can be eliminated by hitting the bottom side of the left armrest with your hand and at the same time gently rotating the button used to raise and lower the backrest clock-wise. Once the thread and the slider align the problem is solved and the backrest can be raised and lowered with the button easily.

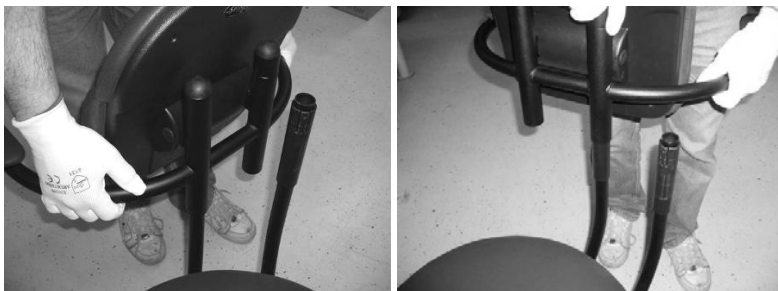
B) Another cause of a problem can be a misalignment of tubes at backrest or at the spring mechanism.

To test if the stated reason is the cause of deficiency please put the bearing on one tube without installing the button and test if the backrest tube slides down smoothly. Then repeat the stated with the other bearing.

If both tubes are sliding down normally, test the other tube with the thread, testing both backrest tubes. The button used to raise the backrest will have to be used for one tube. This will at the same time make it possible to check the thread and the nut in the tube.

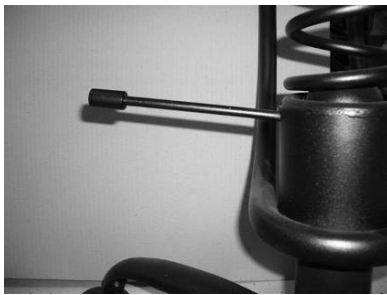
Please check if the lift handle can be moved freely vertically at least 1-2 mm up and down. If yes, the gas pump is most probably faulty and needs to be replaced.

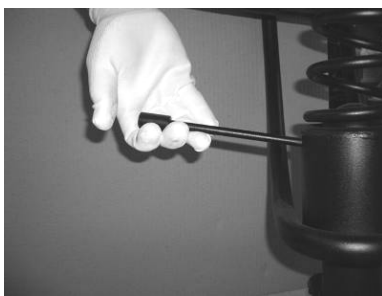
If you are unable to move the lift handle 1-2 mm up and down vertically, this means that it is pressed against the button of the gas pump, which results in an automatic raising and lowering of the SpinaliS® chair. This deficiency can be eliminated by pulling the lift handle with moderate force (as when trying to lift some 15 kg) upwards towards the seat for approximately 5 mm. This will cause a minor bending of the lift handle, which will create some 1-2 mm free movement area for the lift handle. This way the pressure on the button, which was the cause of the problem, will be released.

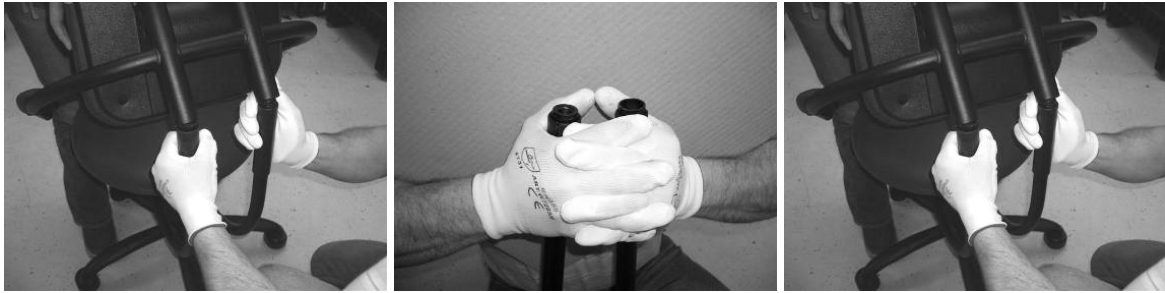
Backrest slowly descends by itself

The cause of this problem can be a lack of friction between the PWC bearing and the backrest mechanism. This fault can be repaired easily.

1. Please unscrew the backrest mechanism and remove it from the seat.
2. Strongly squeeze both bearing tubes together so that the distance between them is some 3-5 cm. Then release them so that they return to their original positions. This will cause a slight change in the alignment and the backrest button will no longer unscrew by itself.

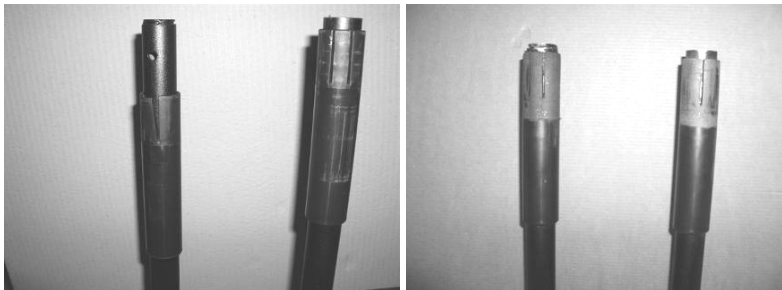
If the bearing slides down the tube at a reassembly of a SpinaliS® chair, you have to lift it up to the height at which you are able to fix the pin into the hole in the tube.

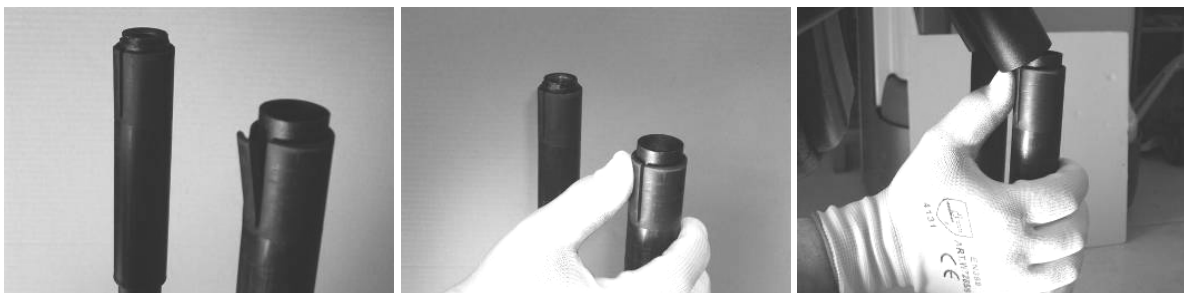
If the pin is bent, please push it back to the correct position with your fingers and fix the backrest. If the pin is broken, please remove the bearing from the tube and replace it with a new one.

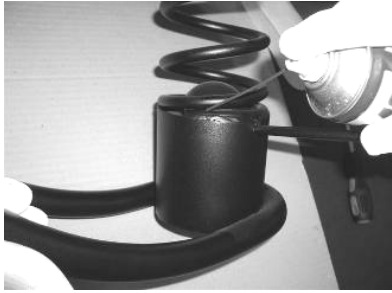
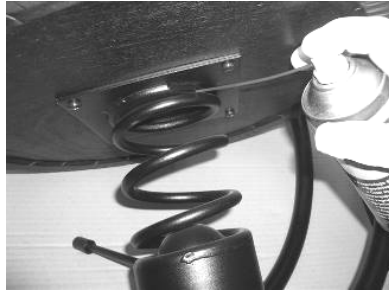
It is possible that the spring starts creaking, when the user is seating on a SpinaliS® chair or is moving the seat. Please apply some grease or KENT WHITE GREASE or oil onto the beginning of the weld (at the bottom) and/or at the end of the weld (on the top).

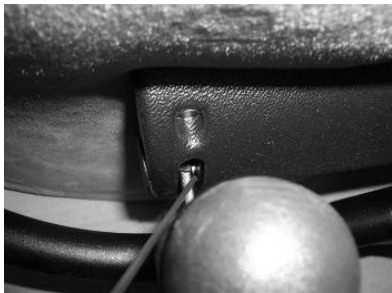
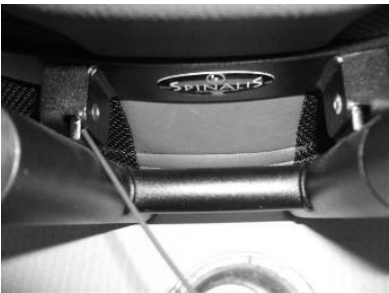
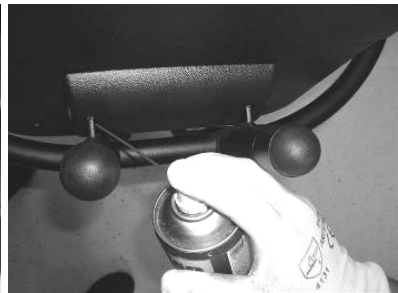
If the backrest creaks when being moved, please apply some grease to the openings as seen on the pictures. Please apply a couple of short squirts of KENT WHITE GREASE as indicated and the problem should be eliminated.

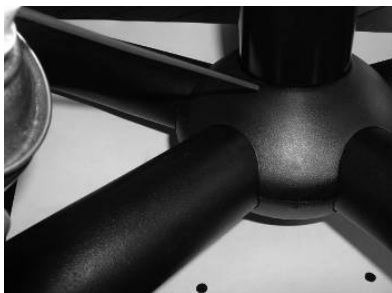
Creaking can also occur where a gas pump is inserted into the metal base. You can get rid of the creaking by applying a couple of short squirts of KENT WHITE GREASE from all directions into the slot of the gas pump.

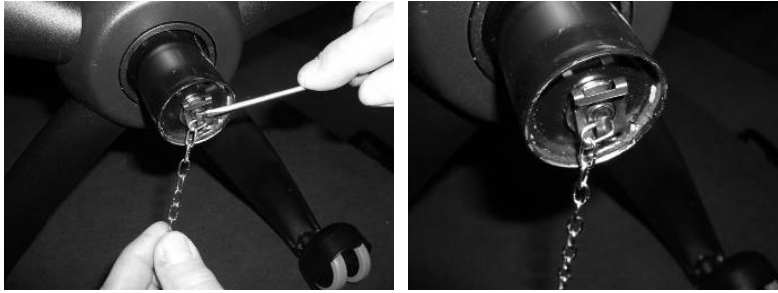
During the winter time static electricity can occur when using the SpinaliS® chair if the SpinaliS® chair is used in dry premises. If you feel static electricity when touching the SpinaliS® chair, please attach a metal chain to the bottom side of the gas pump. This will conduct static electricity into the ground and away from the SpinaliS® chair, which will eliminate the problem in most cases. If static electricity continues to occur, air humidity in the premises has to be raised to at least 60%.

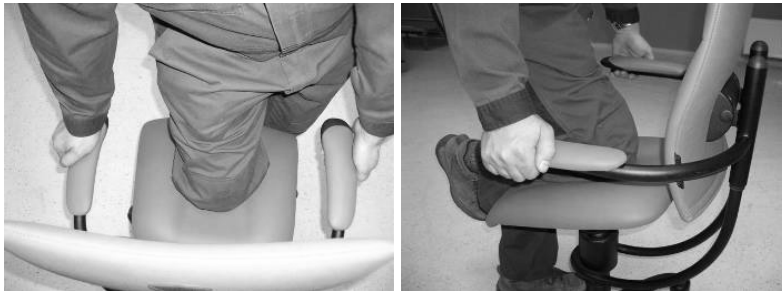
Despite thorough continuous checks of all components during the production process it may occasionally happen that one arm rest is slightly higher than the other due to activities during the welding process.

This default can be removed by applying your force – please place one hand on the higher arm rest and pull the lower arm rest up using sufficient amount of force so that the arm rests are aligned.

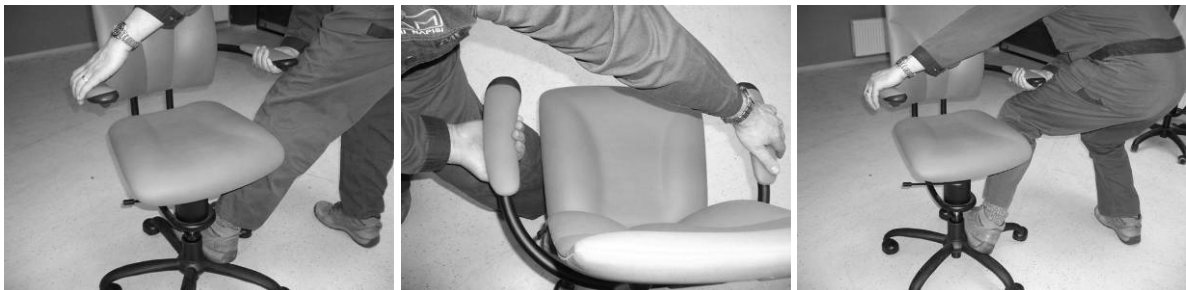
Despite thorough continuous checks of all components during the production process it may occasionally happen that the backrest is slightly misaligned to the left or to the right due to activities during the welding process.

This default can be removed by applying your force – please place your leg on the SpinaliS® chair base, hold the backrest with both hands and pull it to the opposite side until it is aligned with the seat.
